Mucky Marsh Mitigation Site (LRB-2019-00976)

Prepared by:
Ducks Unlimited Inc.
New York In-Lieu Fee Program
LRB-2010-00673 (ILFP)

Date: 23 June 2021

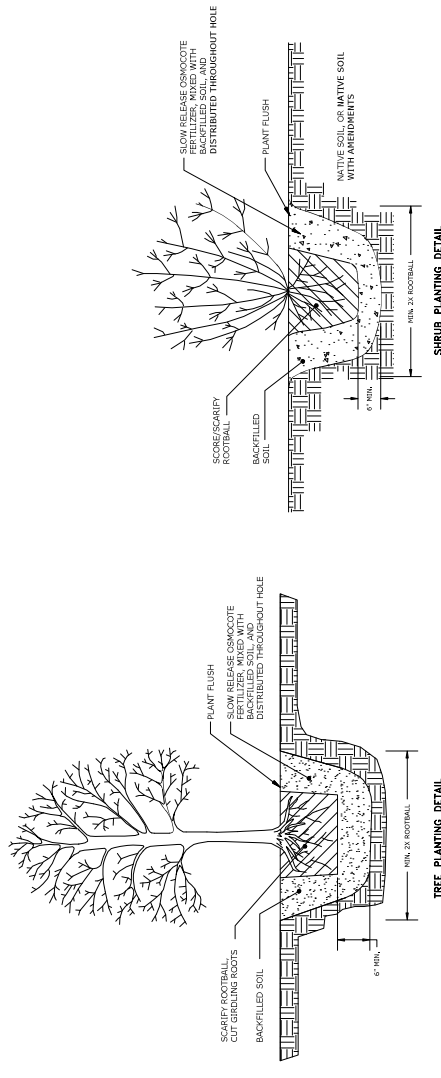
TREE AND SHRUB PLANTING DETAILS

1. WETLAND AND UPLAND BUFFER PLANTING AND RESTORATION AREAS SHALL BE PREPARED PRIOR TO SEEDING. PREPARATION WILL INCLUDE CLEARING (I.E. MOWING) AND HEAVY DISKING OF ALL PLANTING AREAS. PLANTING SHALL BE COMPLETED BY THE DATES OF MARCH 1 AND NOVEMBER 1.
2. THE SEED APPLICATION RATE IS LISTED IN THE TABLE TO THE RIGHT. THE SEED MIX MAY BE MIXED WITH SAND/LOAM OR OTHER INERT FILLER APPROVED BY THE ENGINEER FOR EASE OF APPLICATION. WETLAND SEEDINGS SHALL BE COMPLETED BETWEEN THE DATES OF MARCH 1 AND NOVEMBER 1.
